*Geomorphic and Riparian
Vegetation Assessment
of the
Proposed Napa River Flood Control Project
near the
City of St. Helena, Napa County, California*

Mitchell Swanson, Swanson Hydrology & Geomorphology

October 31, 2002

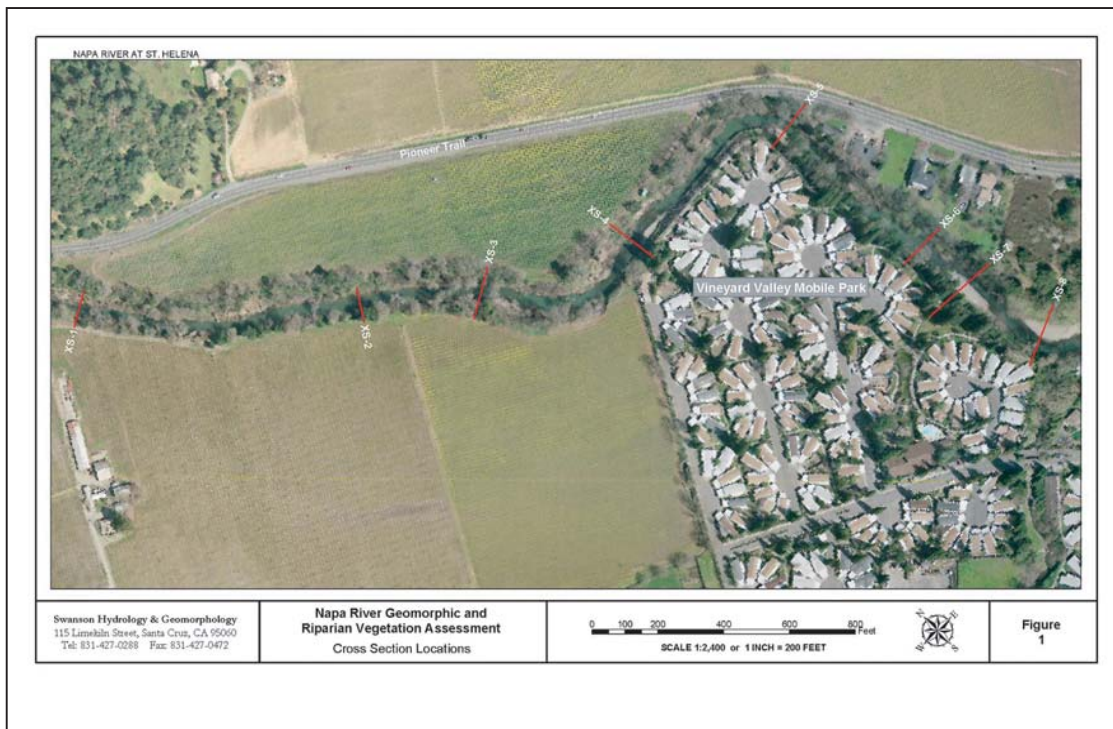
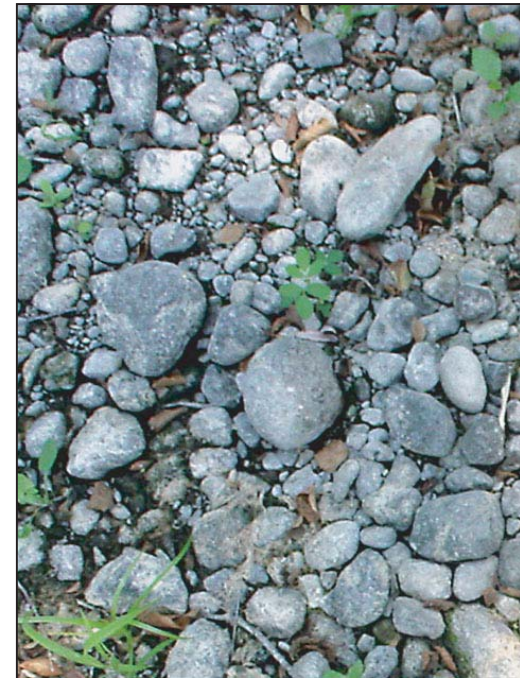
Figure 13a: Pebble count data for each SH&G cross section.

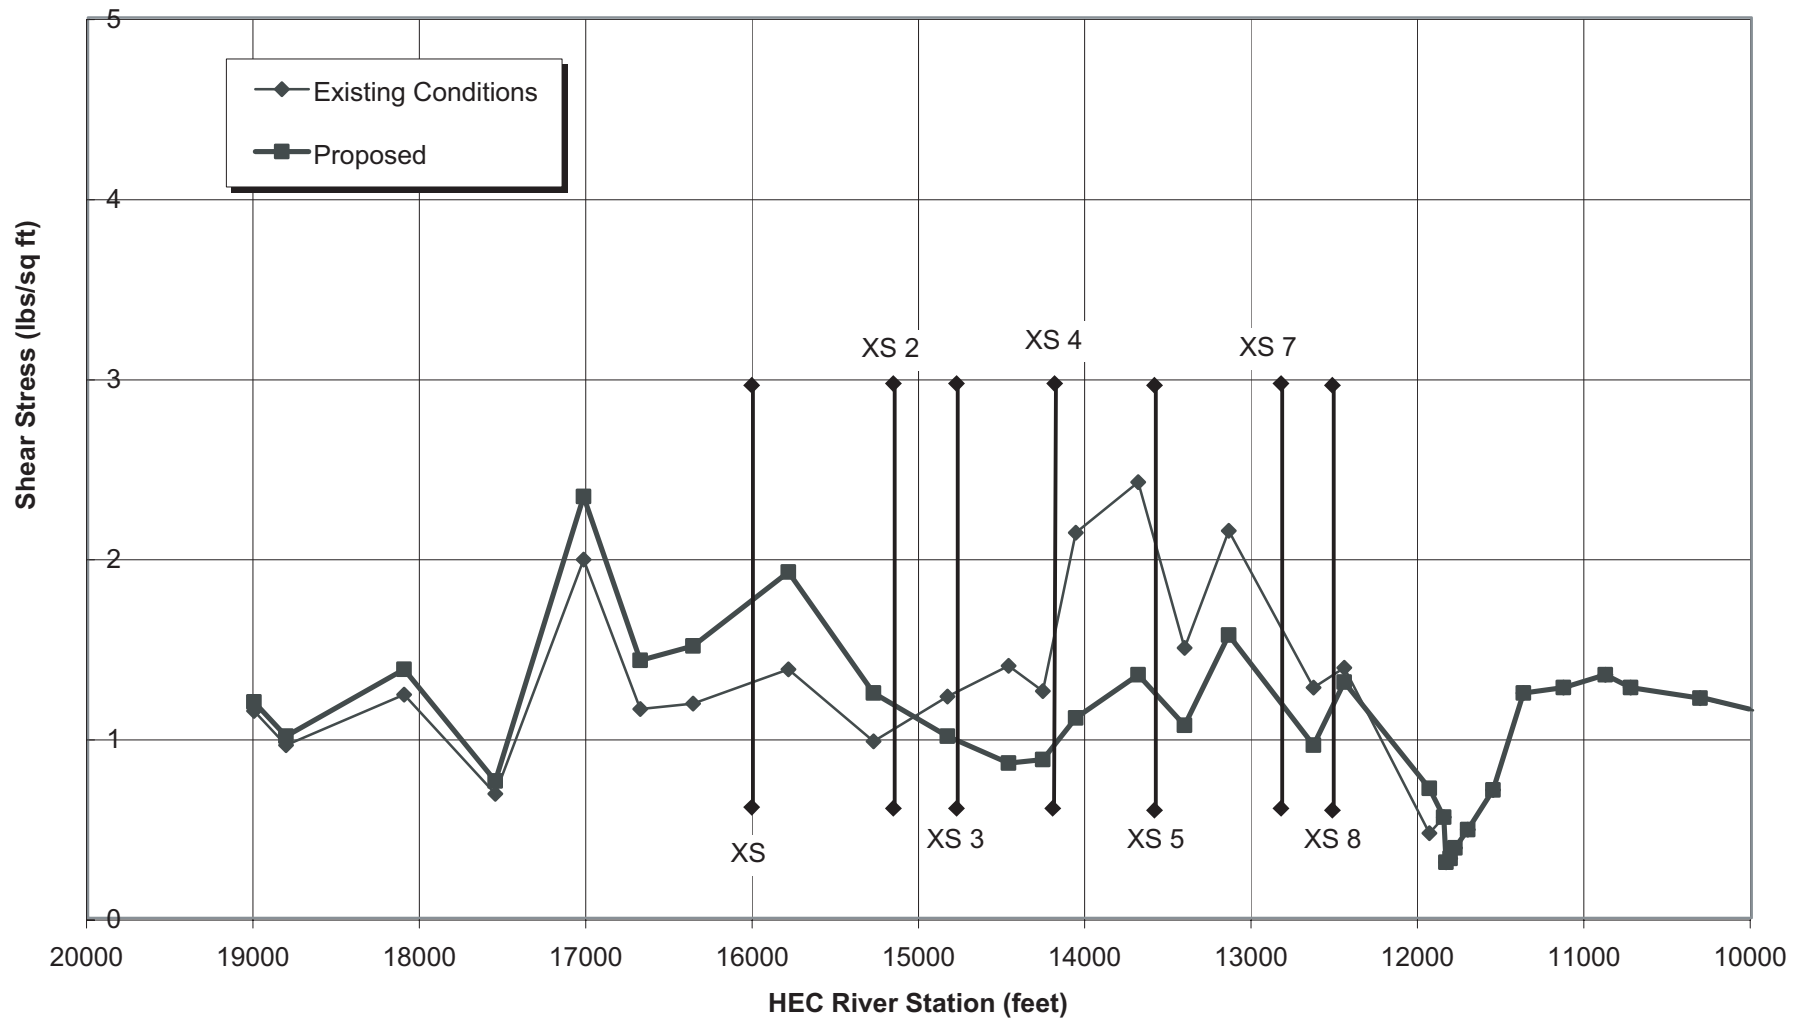
Figure 14a: Shear stress profiles with and without Enhanced Minimum Plan for a 2-year flood. XS refers to location of SH&G cross sections.

A U.S. Army Corps of Engineers computer simulation model HEC-RAS prepared and transmitted to SH&G by MBK Engineers was used to generate computed shear stress of a range of flows at each of the 8 SH&G cross sections where the streambed particle sizes were measured by surface pebble count (**Figure 13a**). The HEC-RAS model can be changed to show hydraulic conditions with and without the proposed terrace excavation project and this is shown in **Figure 13b**. **Figures 14a through 14d** show the computed shear stress for a range of peak floods.

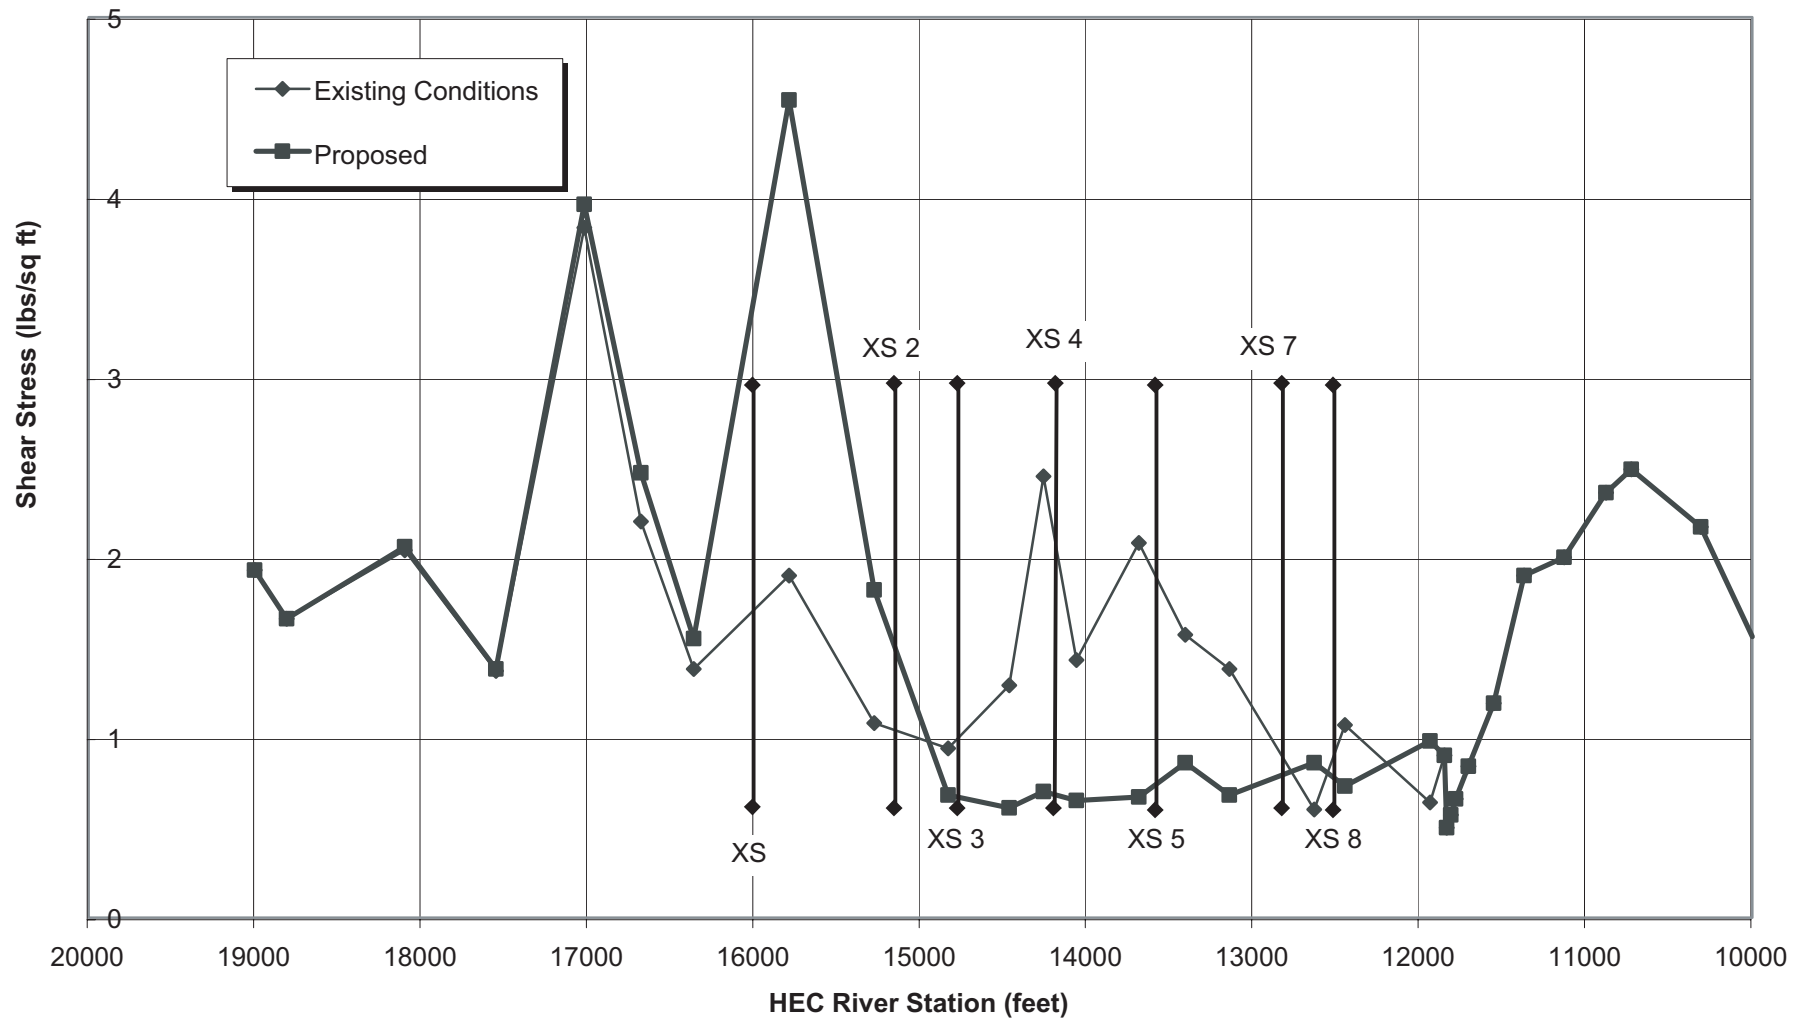
Figure 14b: Shear stress profiles with and without Enhanced Minimum Plan for a 10-year flood. XS refers to location of SH&G cross sections.

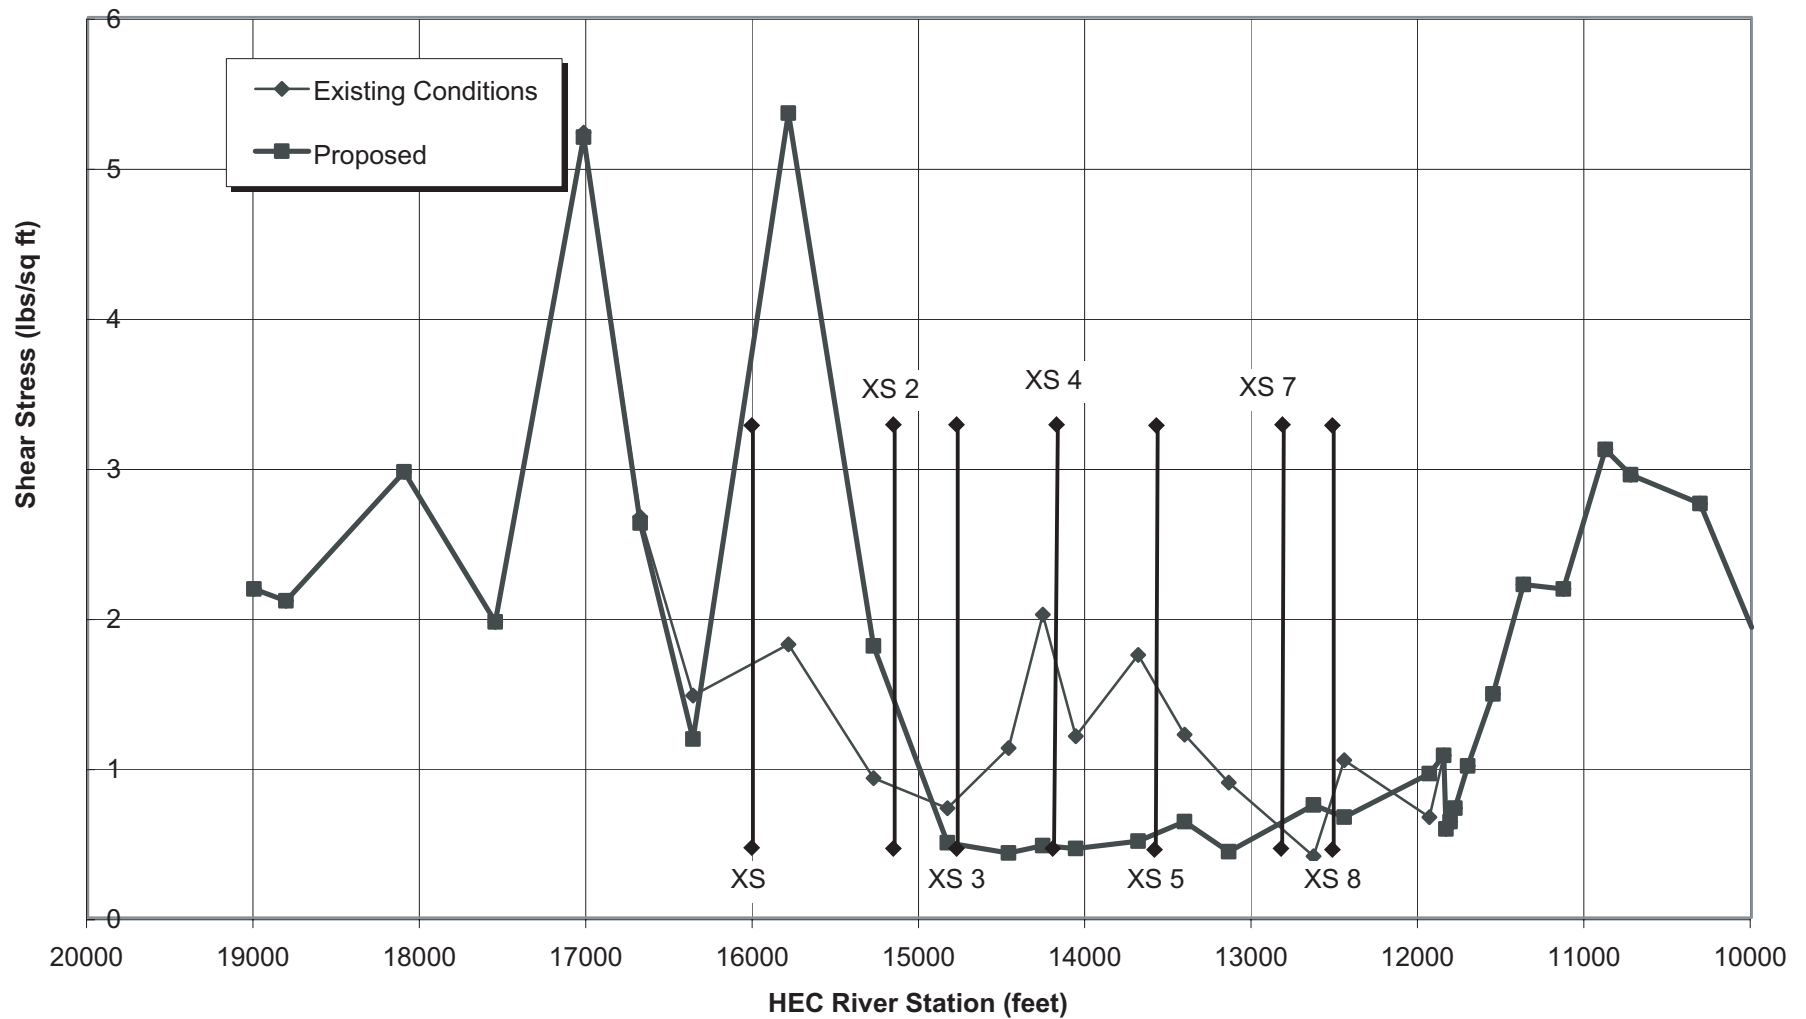
Figure 14c: Shear stress profiles with and without Enhanced Minimum Plan for a 50-year flood. XS refers to location of SH&G cross sections.

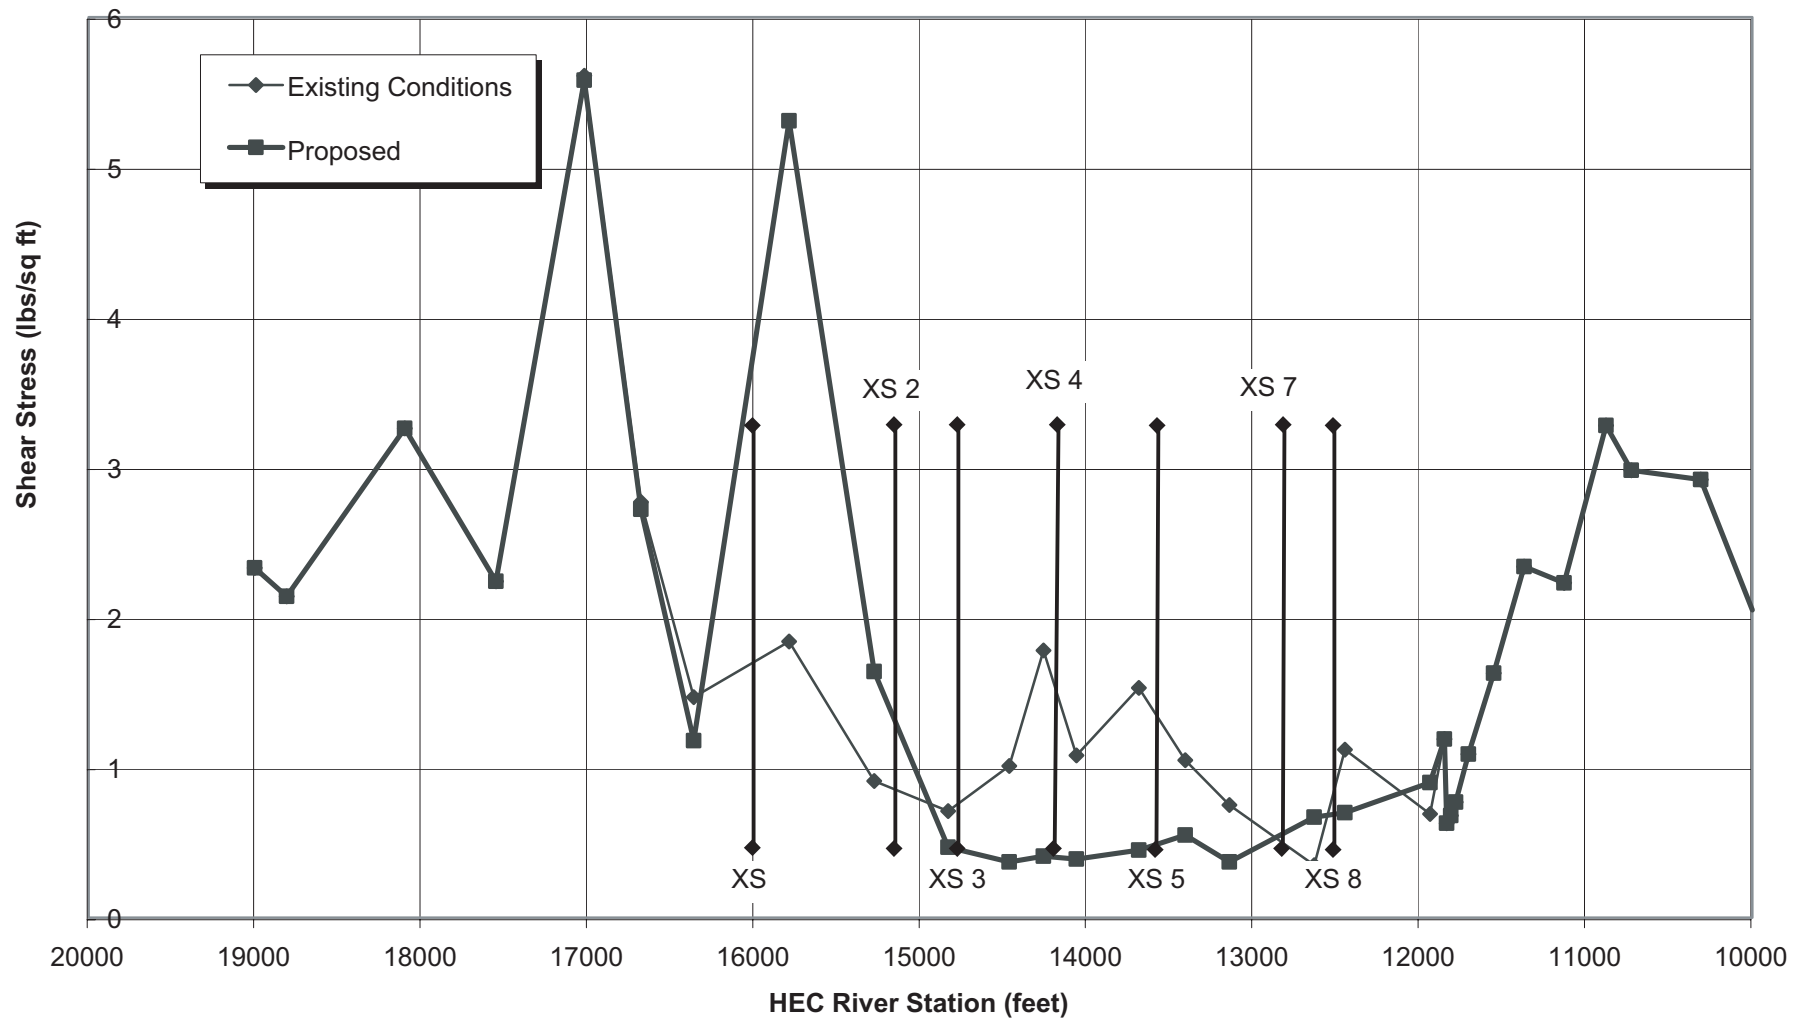
Figure 14d: Shear stress profiles with and without Enhanced Minimum Plan for a 100-year flood. XS refers to location of SH&G cross sections.

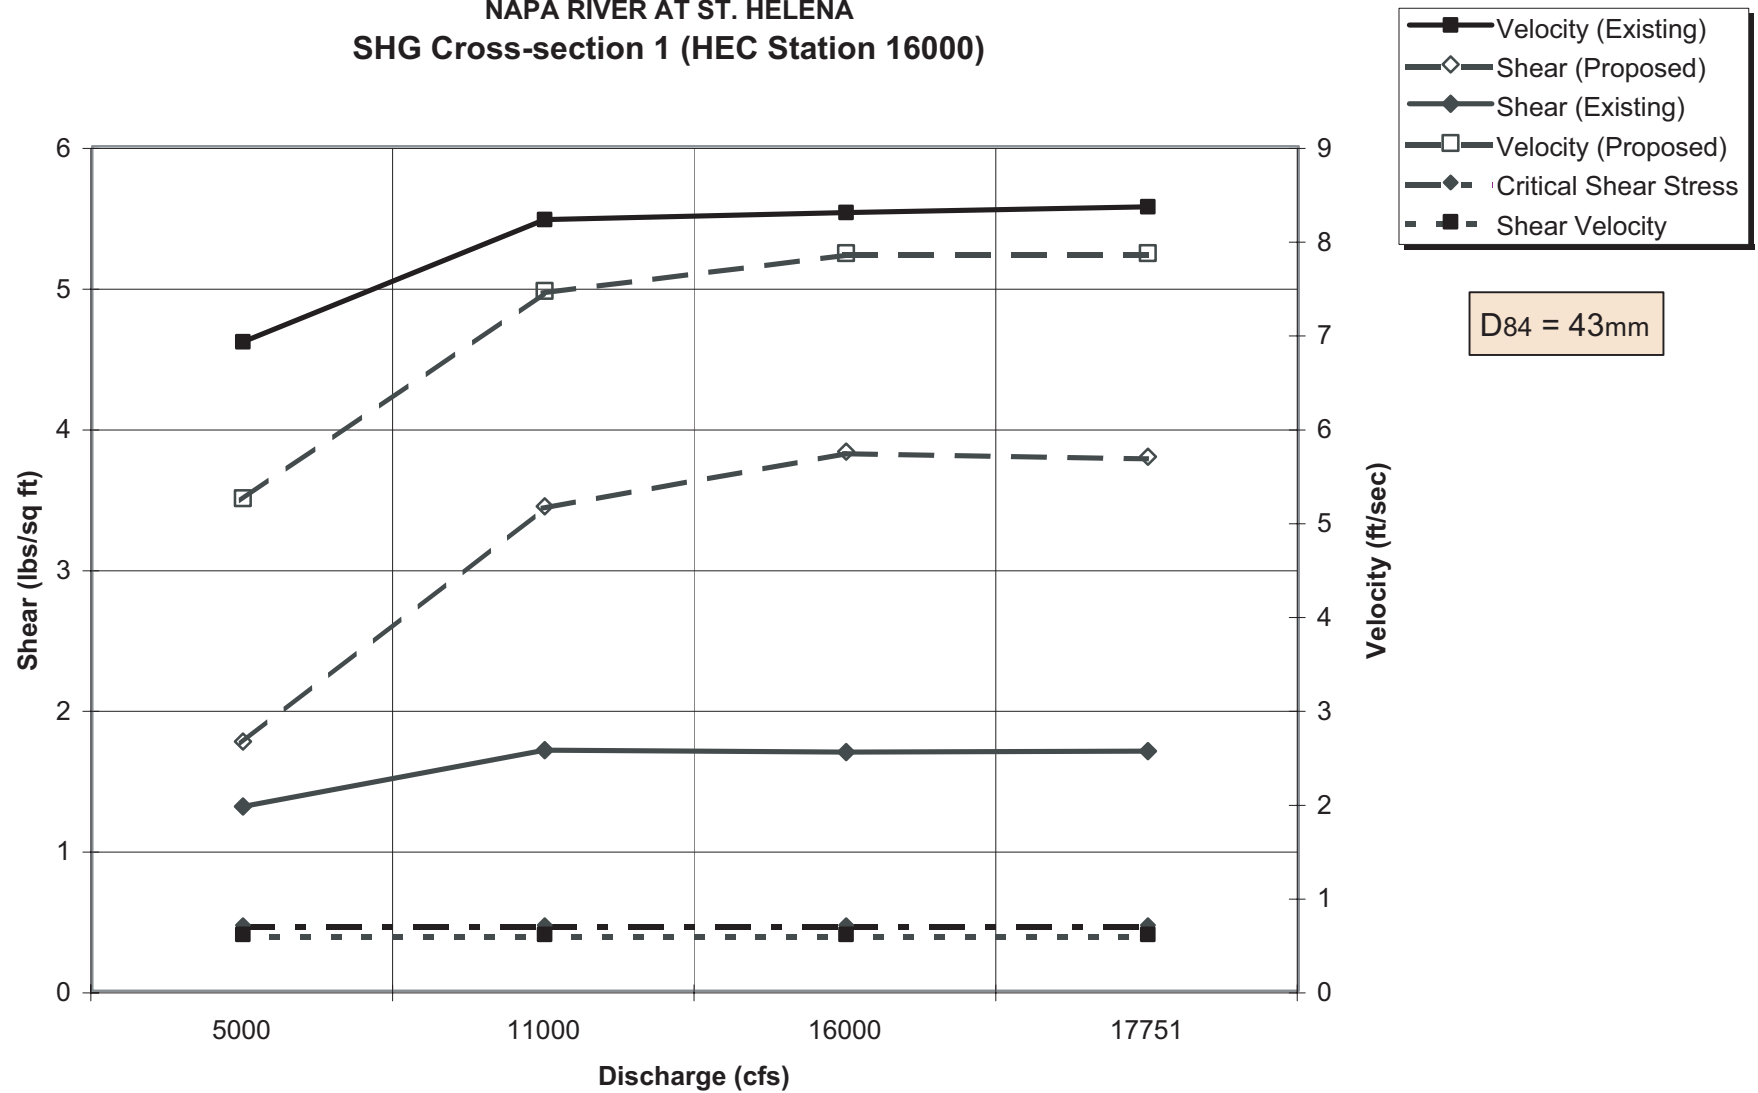
Figure 15a: Plot of shear stress versus flow for SH&G cross section 1.

The proposed project could reduce or increase shear stress and thus sediment transport. **Figures 15a through 15g** show with and without project conditions for a range of flows at 7 of the 8 SH&G cross sections. Each plot shows changes in mean flow velocity in the channel, the changes in shear stress, and the critical shear required to move the 84th percentile largest particle as measured at the SH&G cross section. These results are discussed below.

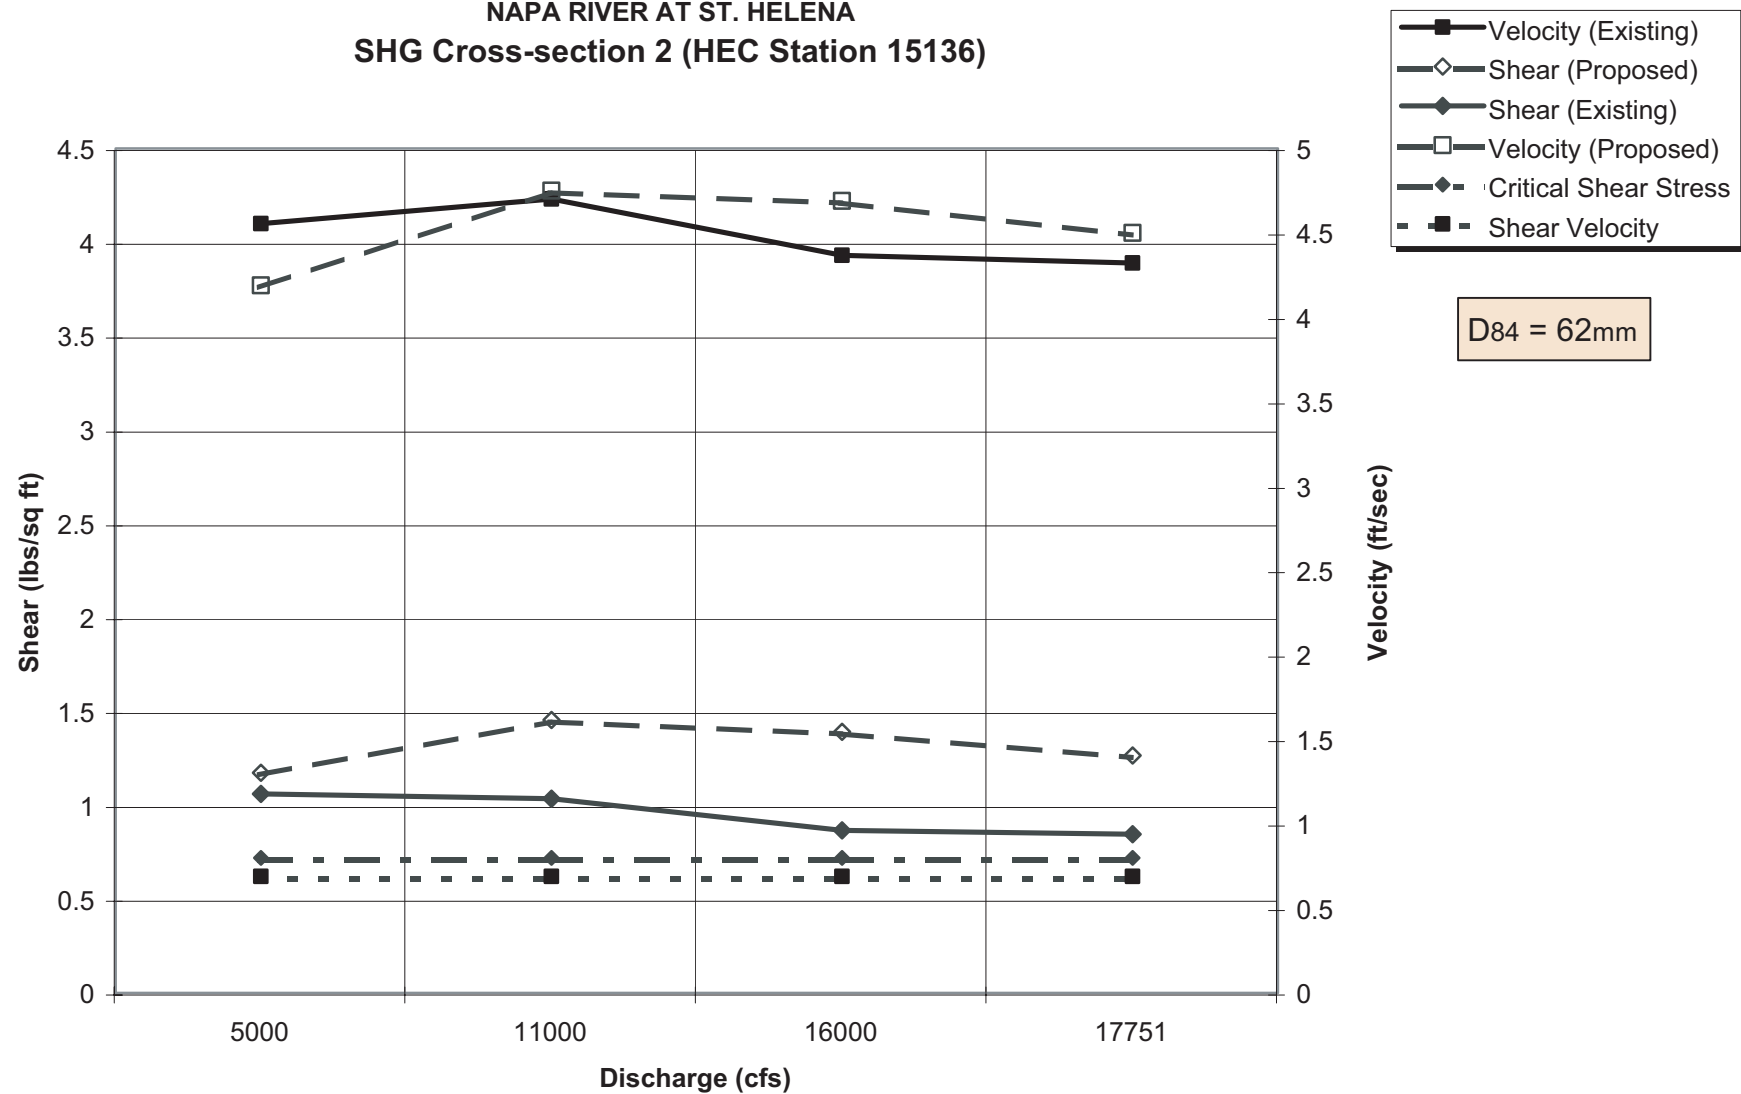
Figure 15b: Plot of shear stress versus flow for SH&G cross section 2.

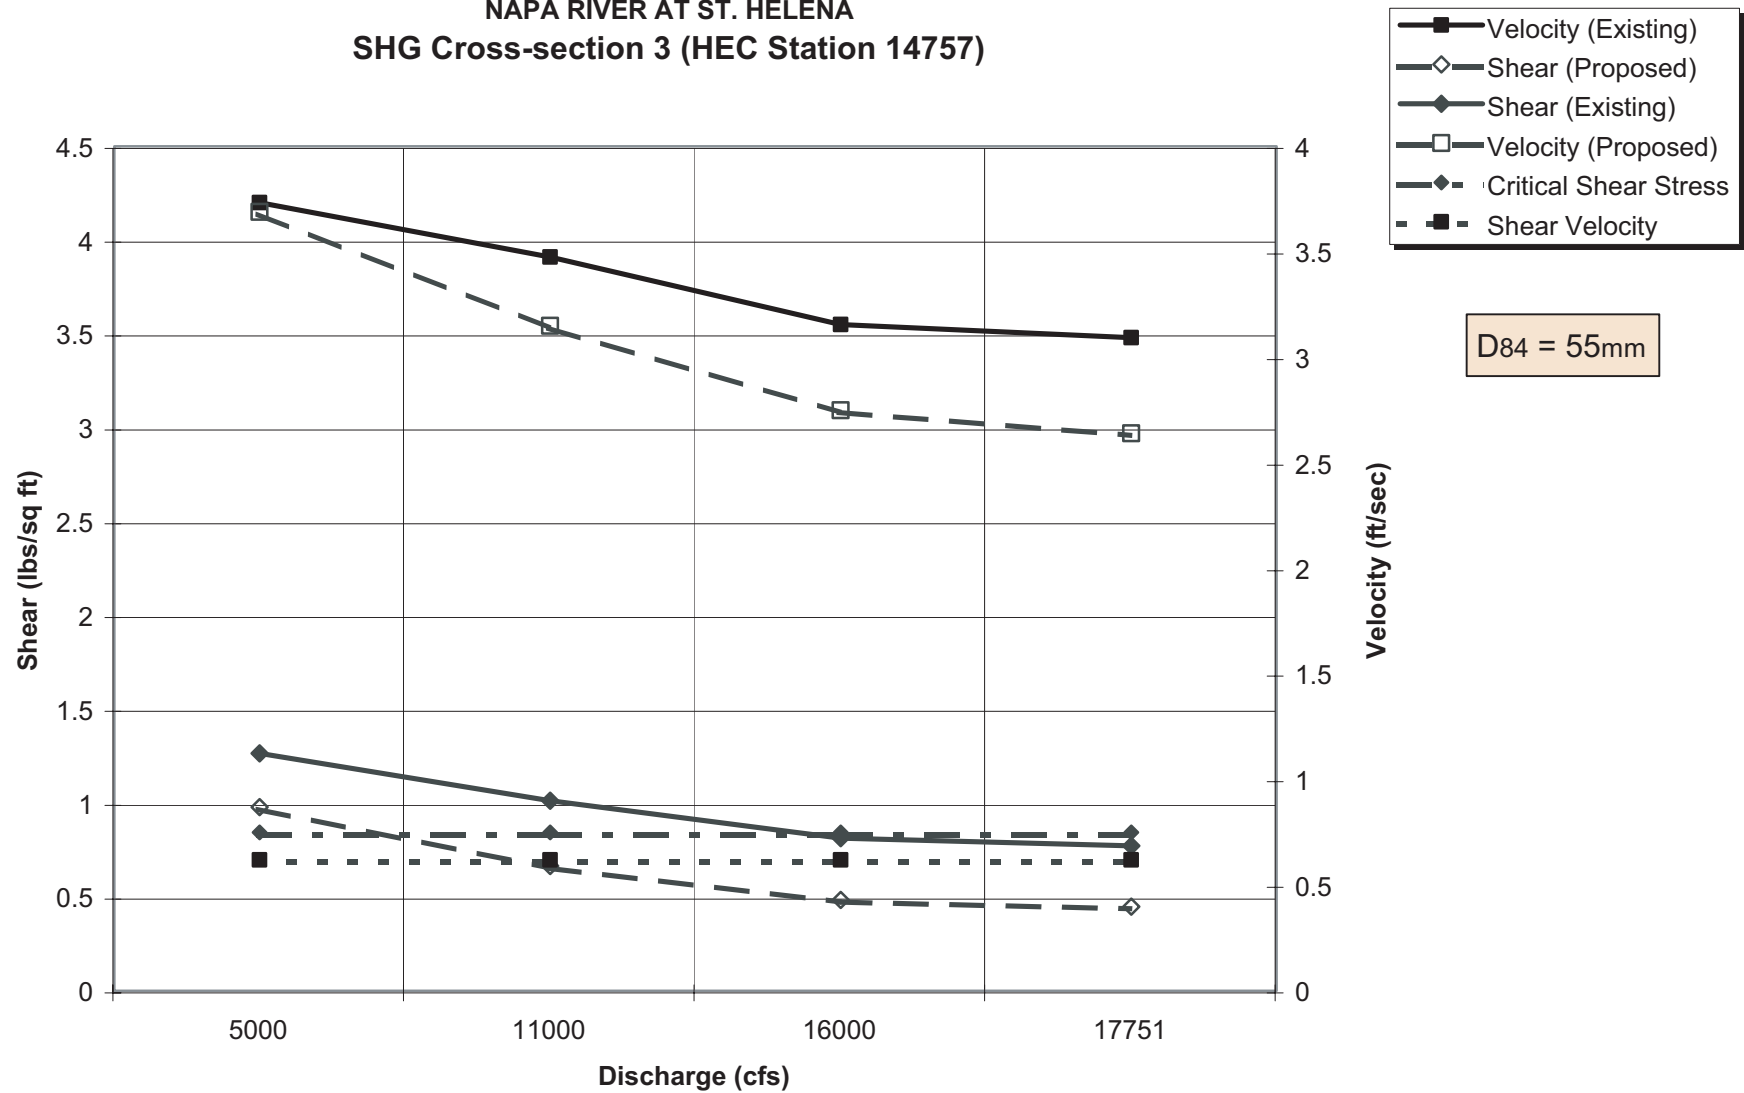
Figure 15c: Plot of shear stress versus flow for SH&G cross section 3.

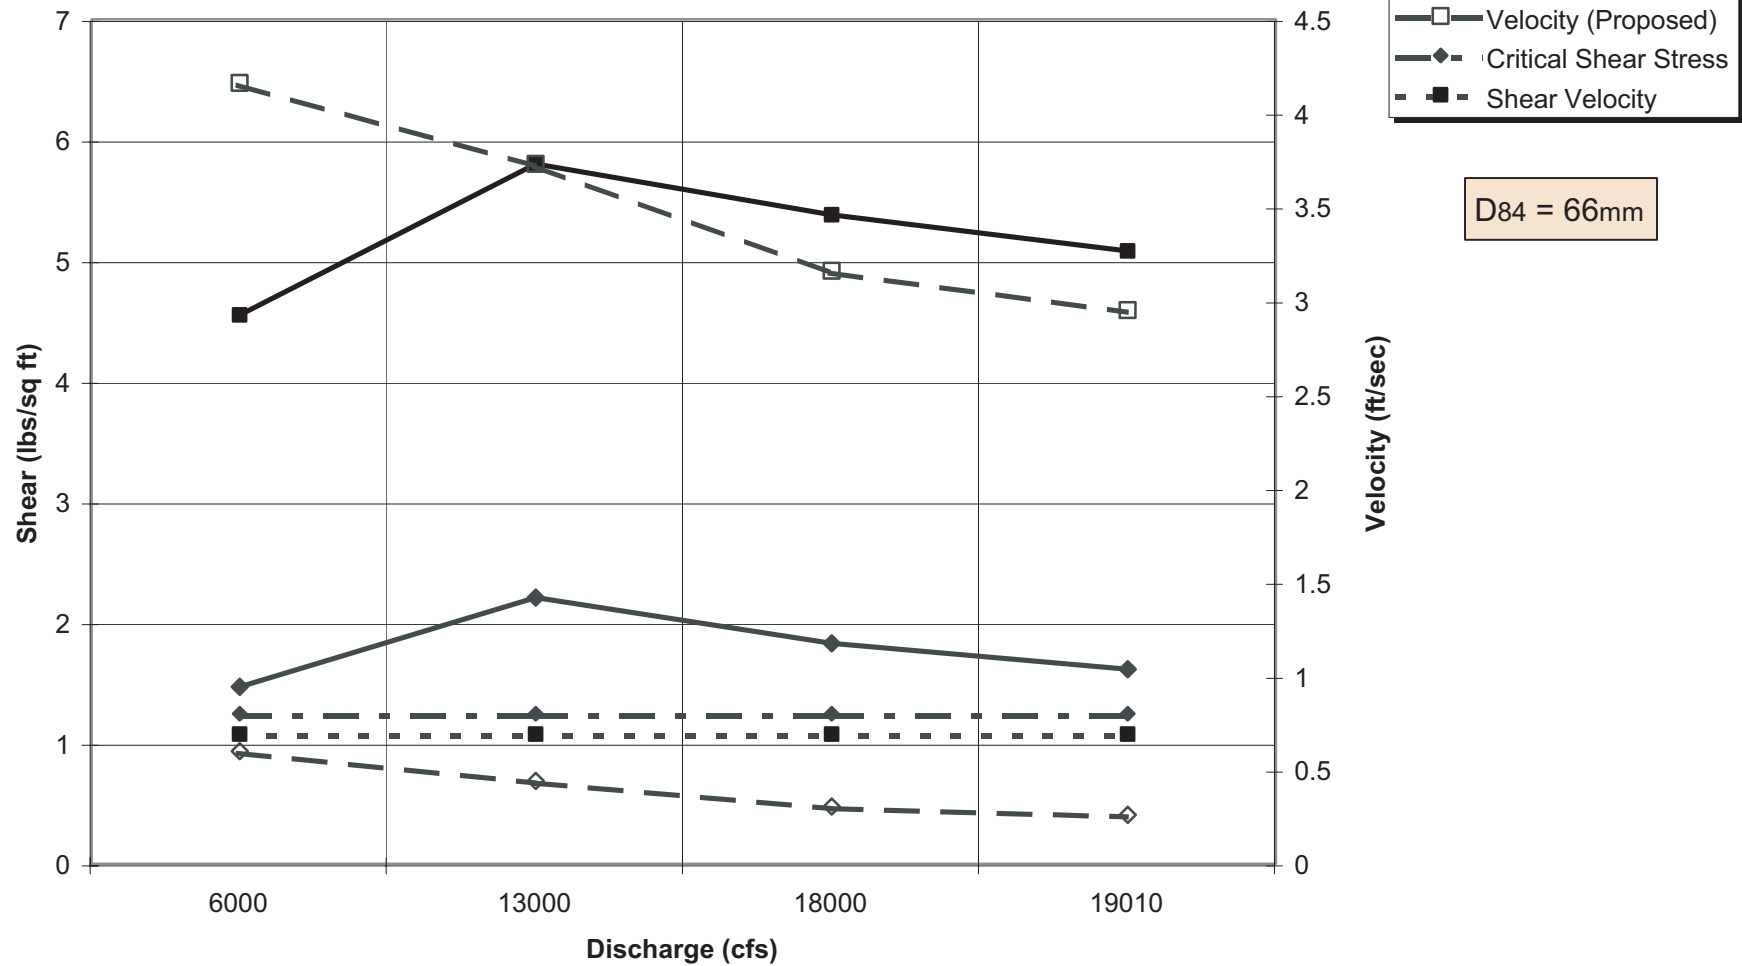
Figure 15d: Plot of shear stress versus flow for SH&G cross section 4.

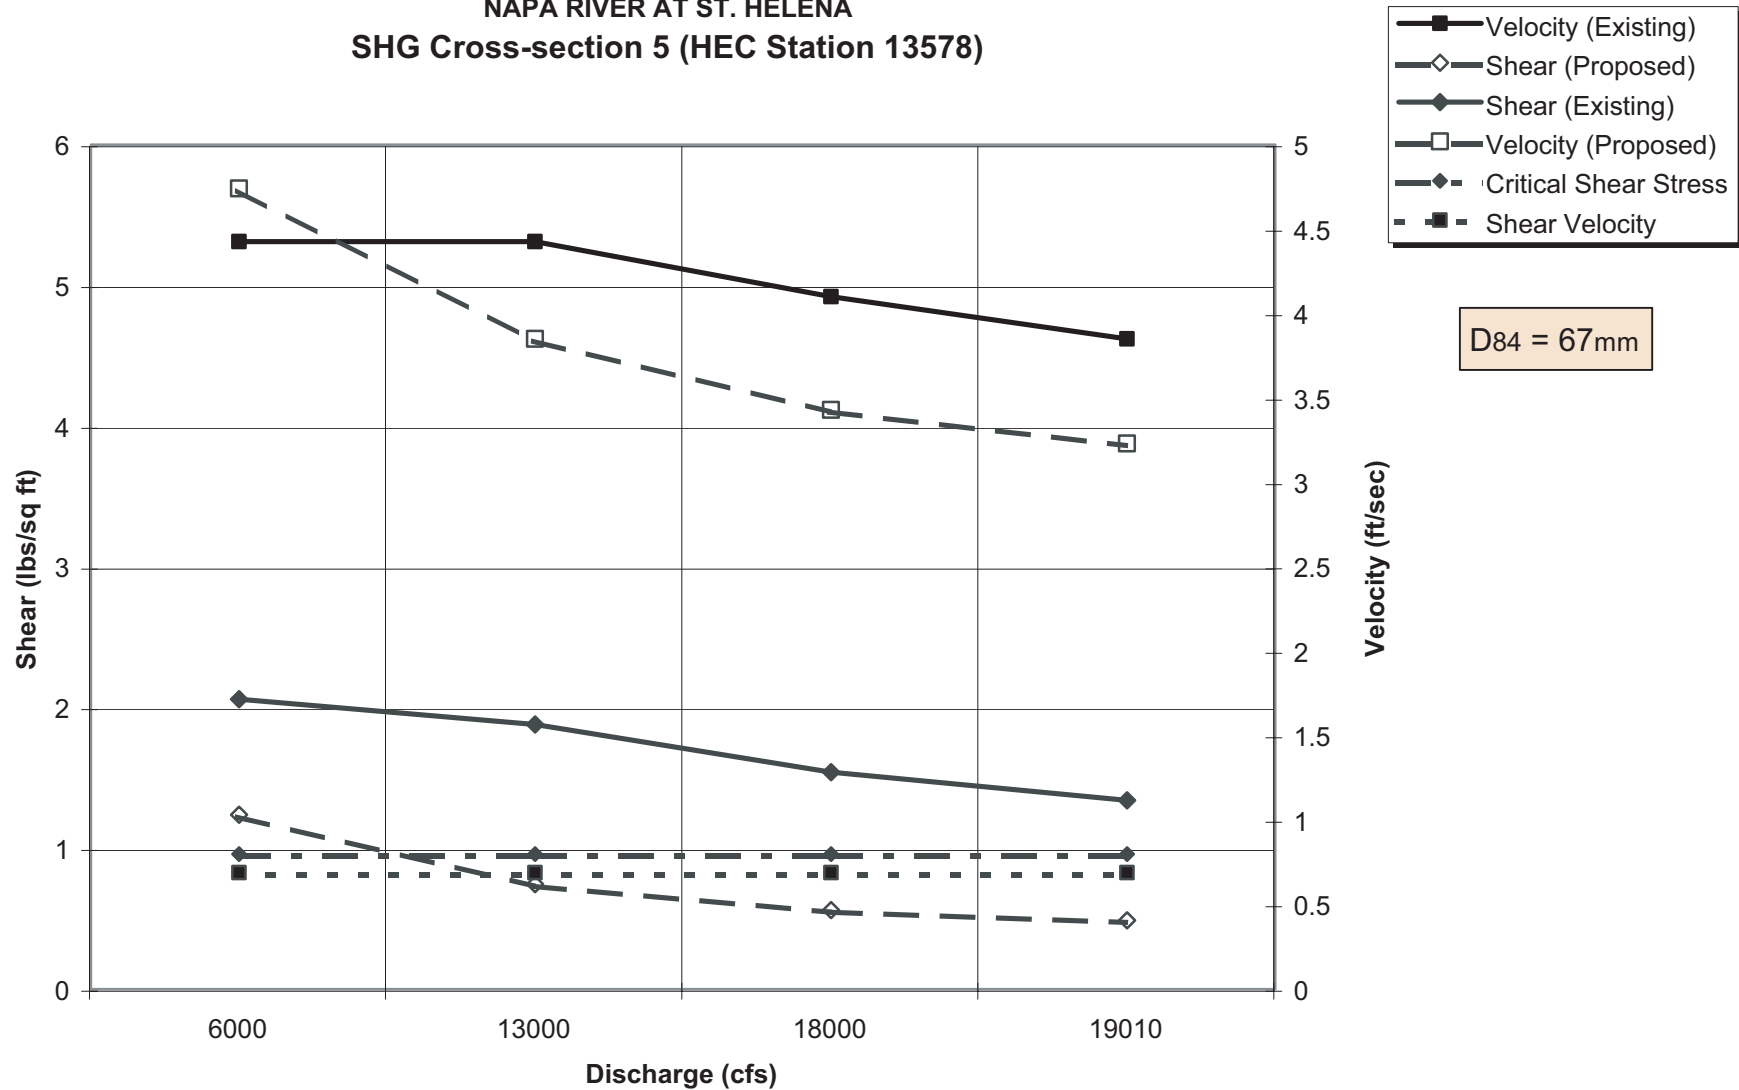
Figure 15e: Plot of shear stress versus flow for SH&G cross section 5.

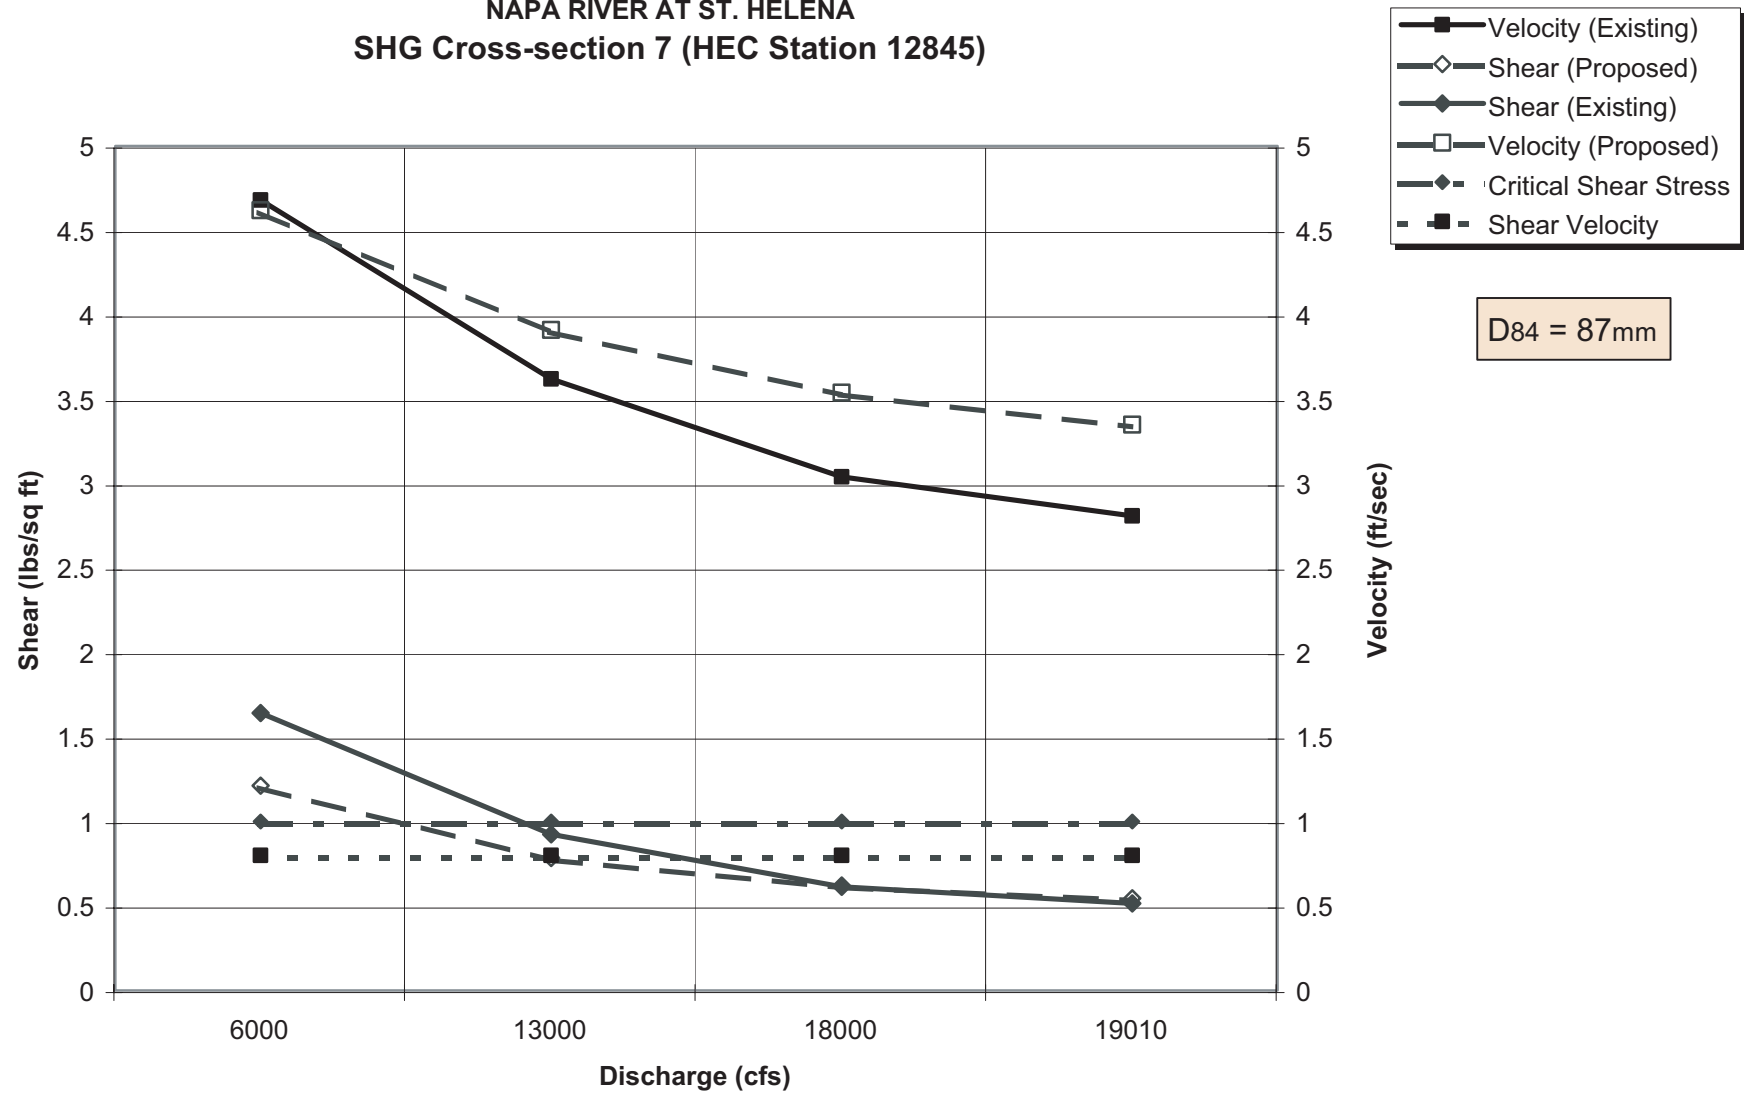
Figure 15f: Plot of shear stress versus flow for SH&G cross section 7.

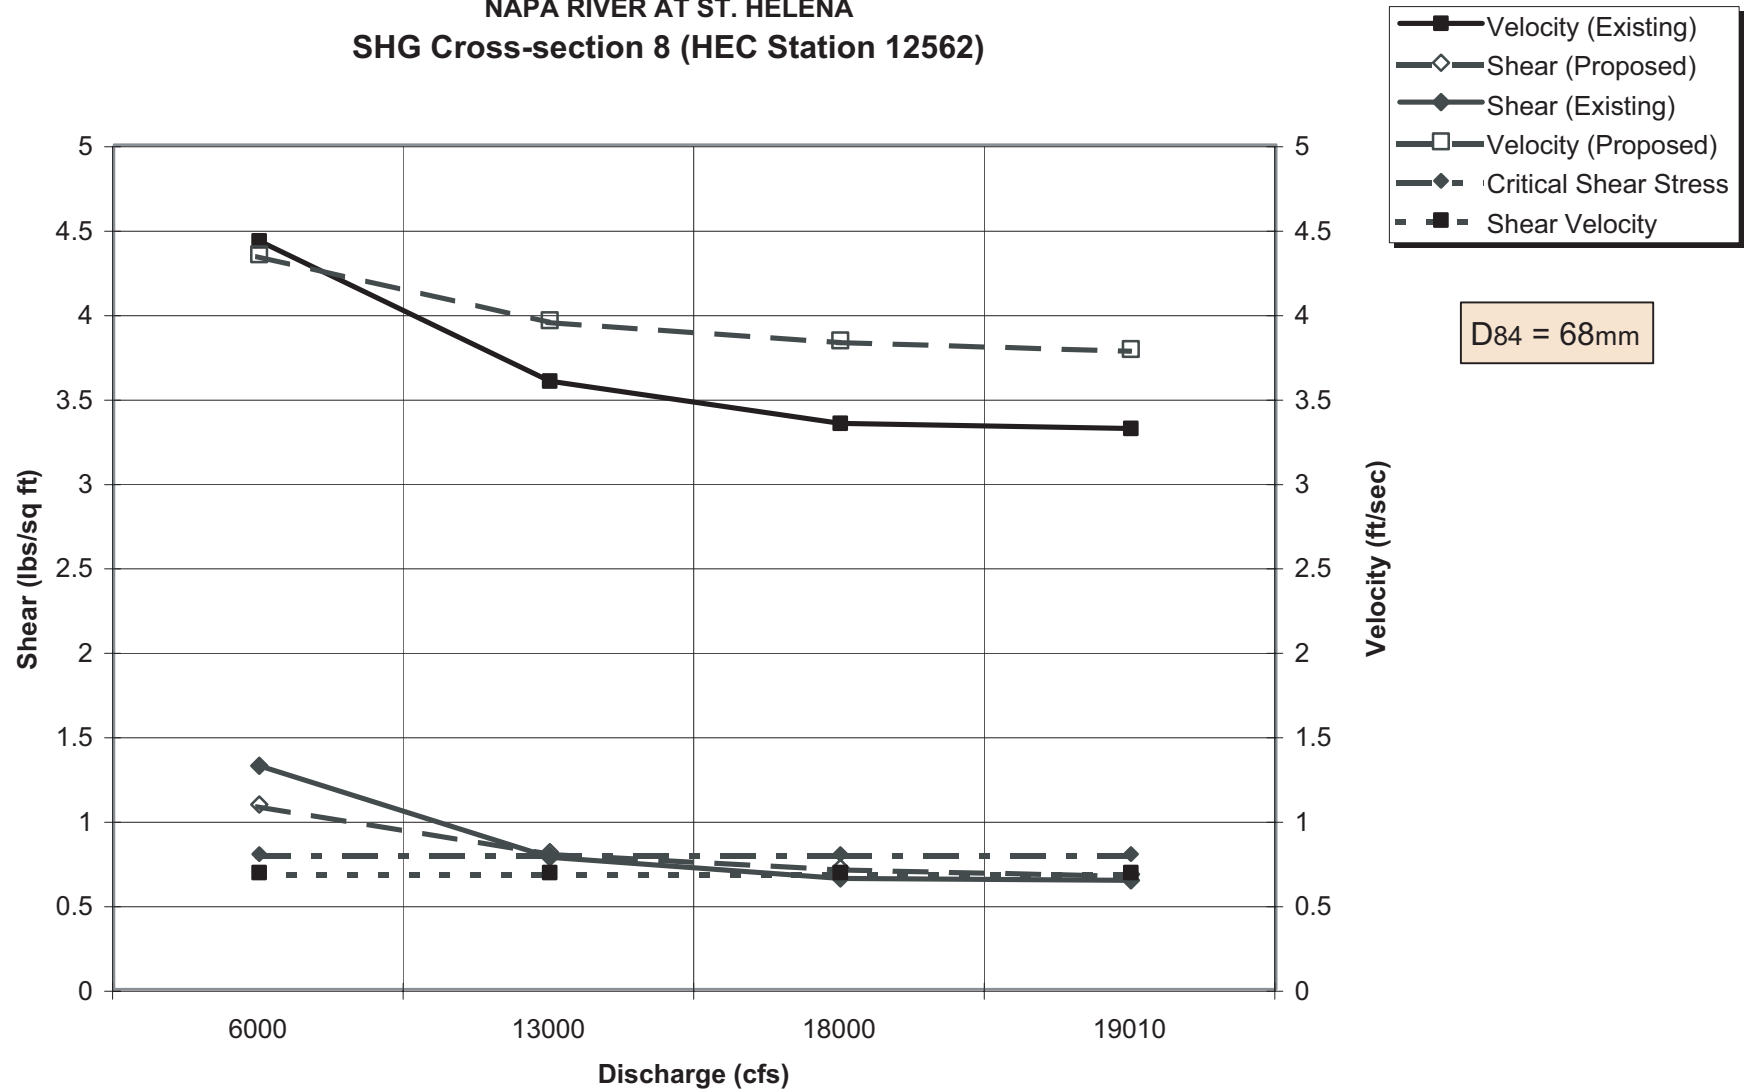
Figure 15g: Plot of shear stress versus flow for SH&G cross section 8.
